GILBERT ASSOCIATES INC READING PA
NATIONAL DAM SAFETY PROGRAM. CEDAR GROVE WEST, NORTH, AND SOUTH--ETC(U)
JUL 78 R J WAHANIK

**CEDAR GROVE WEST,
NORTH, AND SOUTH DAMS
PHASE I INSPECTION REPORT
NATIONAL DAM SAFETY PROGRAM**

NJ 00392

JULY 1978

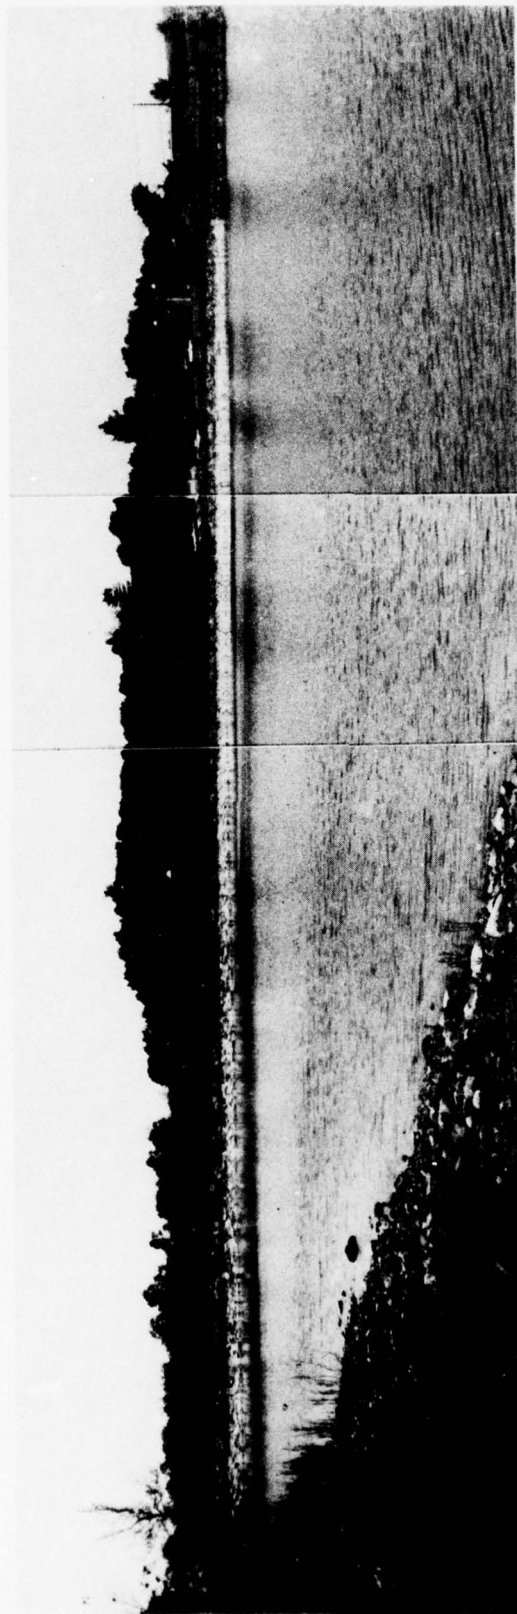
SOUTH DAM

The upstream side of the top of the South Dam appears to have settled slightly since construction, as has the upper portion of the riprap slope of the South Dam. No slope distress was found on the West and North Dams. Some vegetation was found growing in the riprapped slopes of all three dams.

The dislodged and disturbed riprap on the upper portion of the upstream slope of the South Dam was apparently caused by a slope failure or movement of the embankment. This condition should be further studied to evaluate the stability of the dam and to recommend corrective measures.

7.2.1 Alternatives: No alternatives to the studies outlined in paragraph 7.1.4 have been identified. Riprap on the upstream face at the South Dam should be realigned, and the failed slope inspected by a qualified engineer after the repairs have been made.

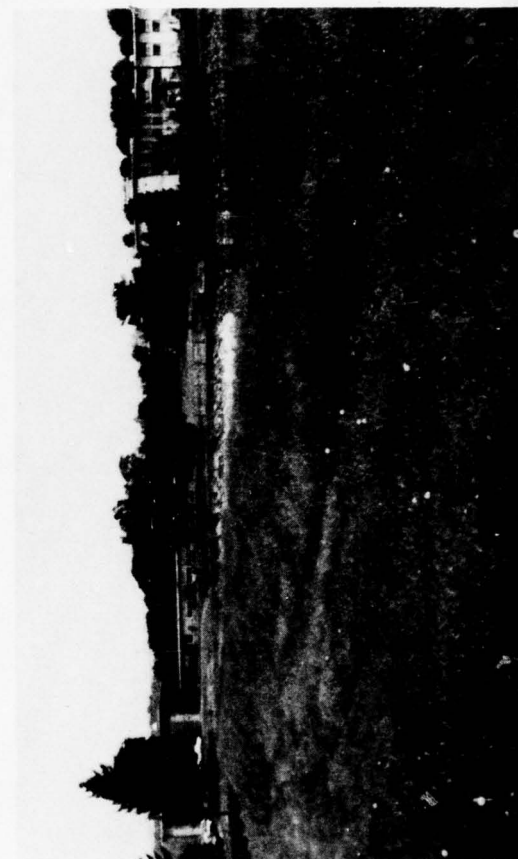
DOWNSTREAM VIEW OF
SOUTH DAM

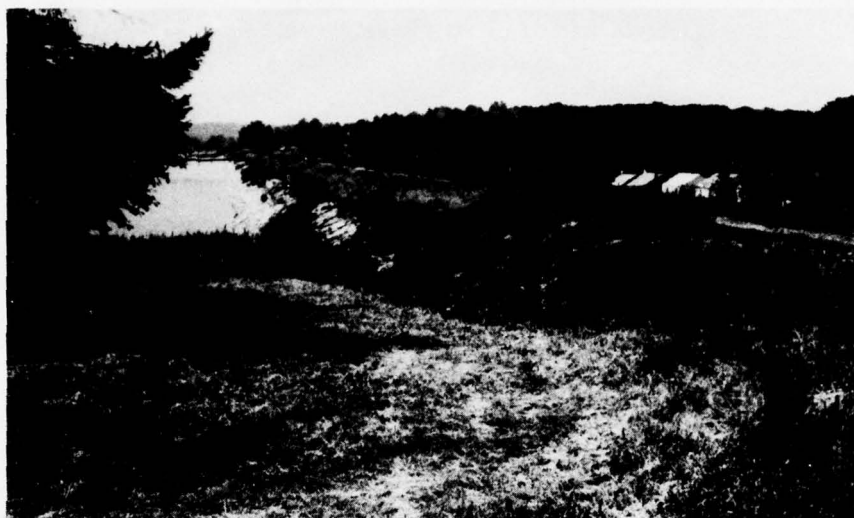
UPSTREAM VIEW OF CREST DAM

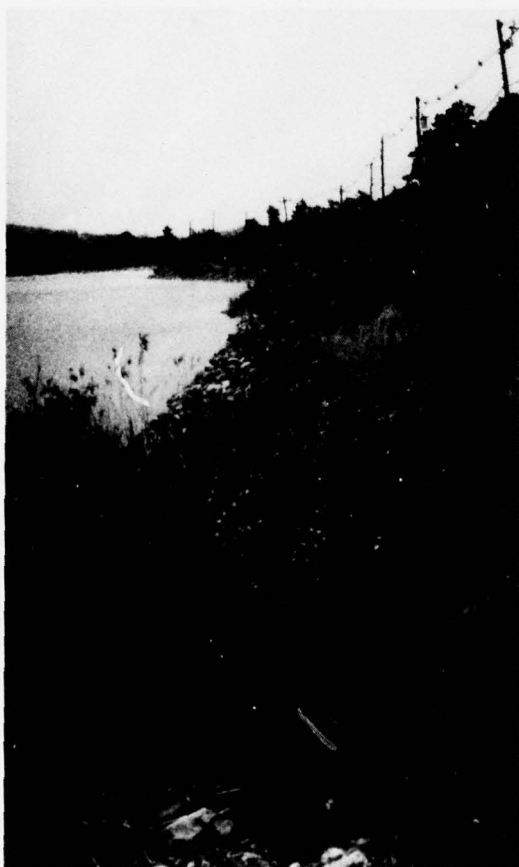
WEST SHORELINE OF RESERVOIR
BETWEEN WEST AND SOUTH DAM

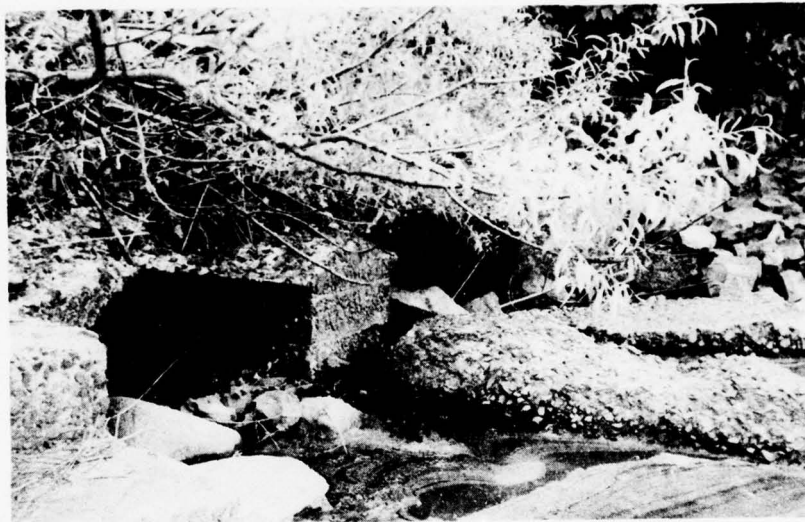
3.1.3 Appurtenant Structures: (a) Spillway - The only spillway for the reservoir is located at the east end of the North Dam. The entrance portion of the twin concrete ducts has been badly damaged, and is partially blocked by debris. The twin 28.5-inch high by 56-inch wide ducts are still serviceable. The spillway section itself appears in good condition, and has been modified since the record drawing was made in 1905.

INLET TO EMERGENCY SPILLWAY

The entrance section of the twin concrete ducts of the spillway on the east end of the North Dam should be repaired. Debris accumulated in front of this intake should be removed.
